OWNER NOTIFICATION CAMPAIGN

November 3, 2014

Service Advisory: 14-215

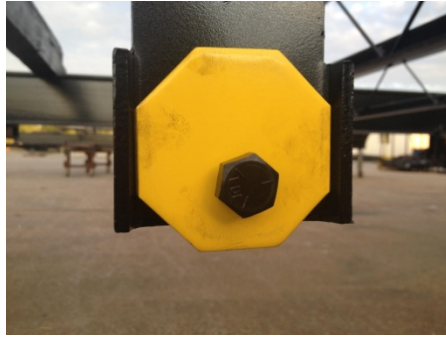
Inspect the inner and outer octagon Correct Track cam plates located on the front and rear axle spring hangers on both sides of the unit. Each unit has a total of eight (8) plates for tandem axle trailers and twelve (12) for triple axles. The correct measurement for the overall size of the plate is 3". Plates manufactured out of specification will be less than 3".

Correct

Cam Plates Shown In Original Manufacturing Position

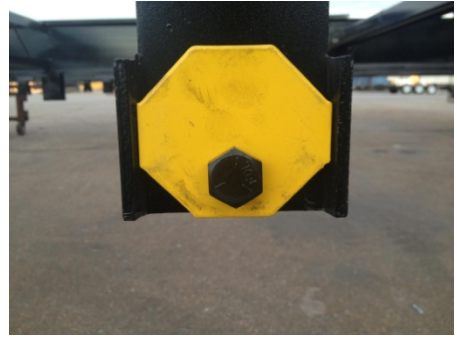
It has been determined that the octagon Correct Track cam plate on certain vehicles may have been manufactured out of specification. If the hanger has the defect part **and** the involved component **has been adjusted** from the original manufacturing setting, it may allow excessive suspension movement possibly causing abnormal wear of the suspension components or tires. The component, **as installed and not having been adjusted**, poses no safety problem and should be **inspected for the below condition** and replaced allowing adjustment in the future **should it be required**.

Incorrect
